Manhole Inspection Summary

Manhole # S55C1_006MH

Insp Date: **7/23/09 12:21 PM**

Location Address: **2301 Keith St**

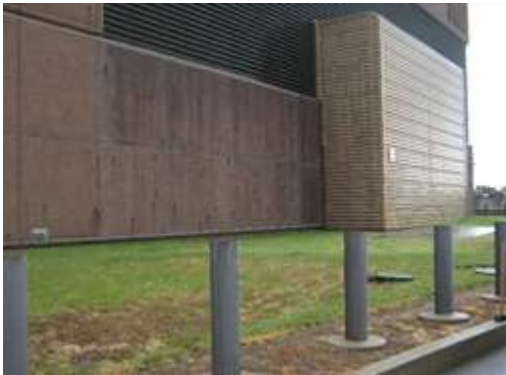
Location View

2301 Keith St

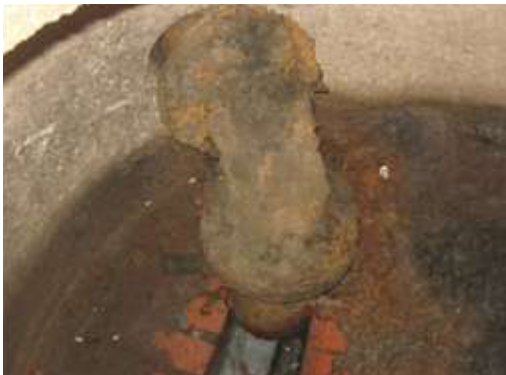
Miscellaneous

service line top view

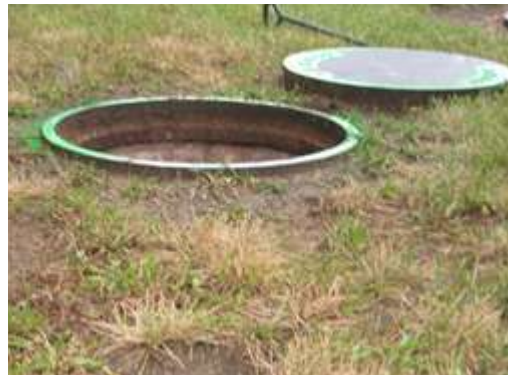
Miscellaneous

A/B grade +1

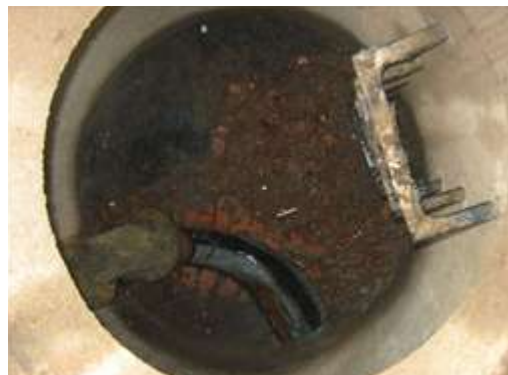
Defect 2

Condition: ☐ Sound ☐ Cracked ☐ Root Intrusion ☐ Deteriorated ☐ Leaks ☒ **Debris**

sediment on bench

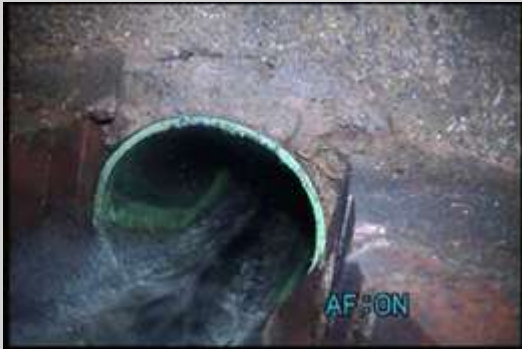
12 O'Clock Outflow

8 in. Circular Gravity Sewer
Pipe Out @ 12 O'Clock

Pipe Height: **8.4** (in.) Rod and Bar (Angled)
Pipe Material: **Clay** ☐ Pipe Lined
Invert Depth: **7.50** (ft.) Flow Characteristics: **Fast**
Deposits: ☒ None ☐ Mud ☐ Sludge ☐ Debris ☐ Grease
Silt Depth: **0** (in.) Deposits Extent:
Infiltration: **None** Pipe Seal Cond: **Sound**

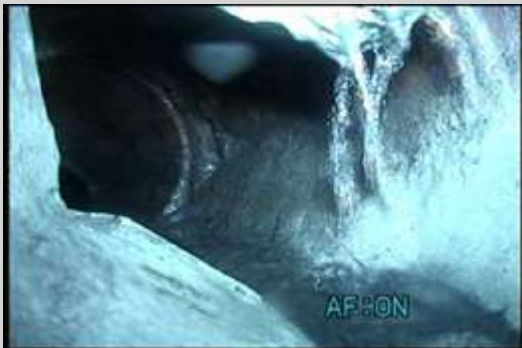
3 O'Clock Inflow

6 in. Circular Gravity Sewer
Pipe In @ 3 O'Clock

Pipe Height: **6** (in.) Rod and Bar (Angled)
Pipe Material: **Clay** ☐ Pipe Lined
Invert Depth: **7.40** (ft.) Flow Characteristics: **Fast**
Deposits: ☒ None ☐ Mud ☐ Sludge ☐ Debris ☐ Grease
Silt Depth: **0** (in.) Deposits Extent:
Infiltration: **None** Pipe Seal Cond: **Sound**

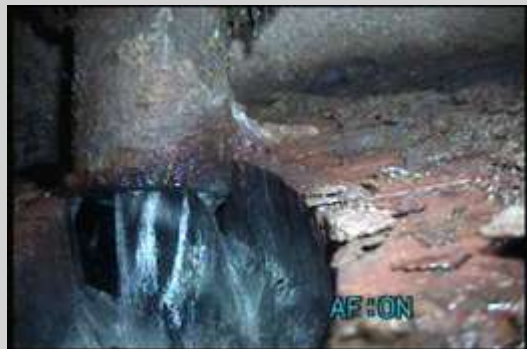
3 O'Clock Inflow

6 in. Circular Gravity Sewer
Pipe In @ 3 O'Clock

Connects To: **House connection / Service line**
